# Geotechnical Engineering Report

VAMC Visitor Parking South  
1901 Veterans Memorial Drive  
Temple, Texas

Terracon Project No. 96155050

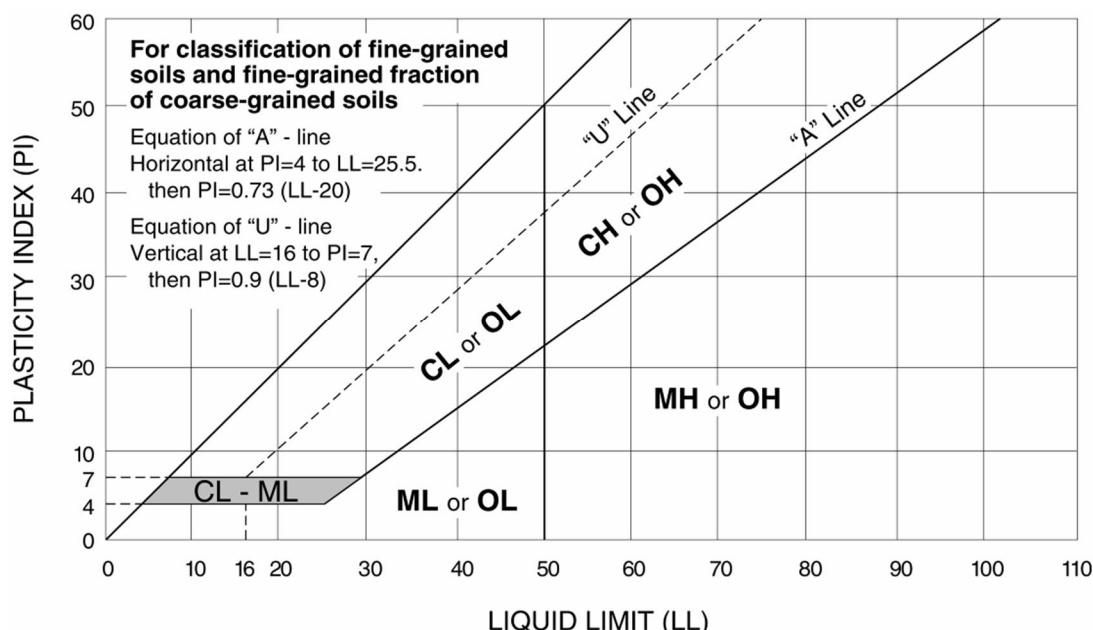
<sup>P</sup> PI plots on or above "A" line.

<sup>Q</sup> PI plots below "A" line.
